Deliverable D 4.5 In-situ measurements on industrial steel ladle finished

Document type **Deliverable D 4.5**
 Document Version / Status **1.11**
 Primary Authors **João Pereira, jpereira@civil.uminho.pt, UMINHO**
 Distribution Level **PU (Public)**
 Project Acronym **ATHOR**
 Project Title **Advanced THERmomechanical multiscale mOdelling of Refractory linings**
 Grant Agreement Number **764987**
 Project Website **www.etn-athor.eu**
 Project Coordinator **Marc Huger, marc.huger@unilim.fr, UNILIM**
 Document Contributors **João Pereira, jpereira@civil.uminho.pt, UMINHO**
Pratik Gajjar, pratik.gajjar@civil.uminho.pt, UMINHO

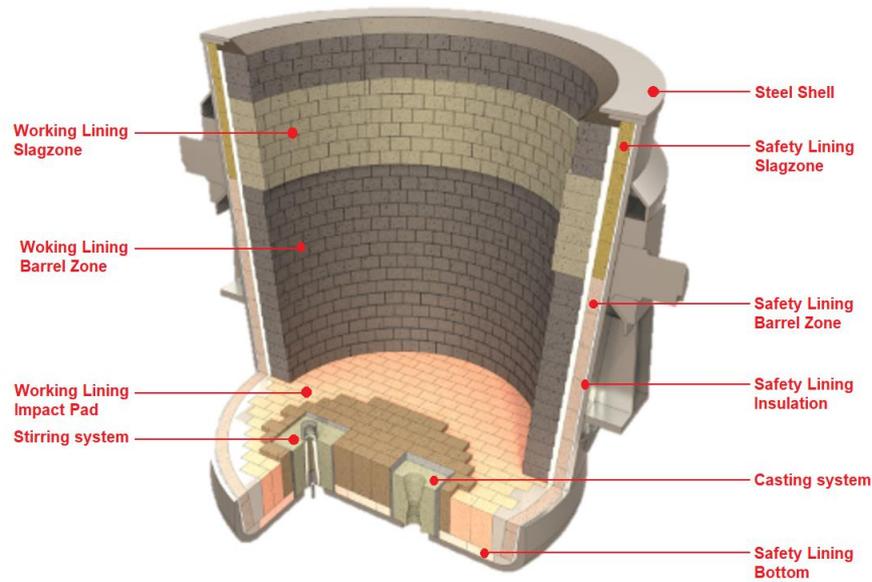
Figure 1 - Steel ladle with different lining zones.

There are various constraints that need to be considered during the design of a steel ladle, for example steel ladles must be reliable while also being economic. The shape of the ladle must guarantee that the maximum amount of molten steel is removed from the ladle during pouring. The ladle must have an impact pad in the position where the molten steel hits the ladle during feeding. The refractories used in the impact pad should have a better mechanical performance compared to the material used in the rest of the ladle. This improved mechanical performance can be achieved by either increasing the thickness of the lining at the bottom of the ladle or by using different materials. The bricks in the slag line must provide resistance against chemical attack from the slag. Other aspects like erosion due to purging, must also be considered. Figure 1 presents a steel ladle and different lining zones.

There are no specific rules for the design of an industrial steel ladle, each manufacturer exploits different aspects of the steel ladle ranging from the refractory lining material to dimensions of the steel ladle. In case of the refractory materials, choices are based on the lining requirement, mechanical, thermal, and chemical performance. For the dimensions, decisions are made considering the lifting capacity of the crane and available movement area, however, in most cases the overall shape remains the same (Figure 1).

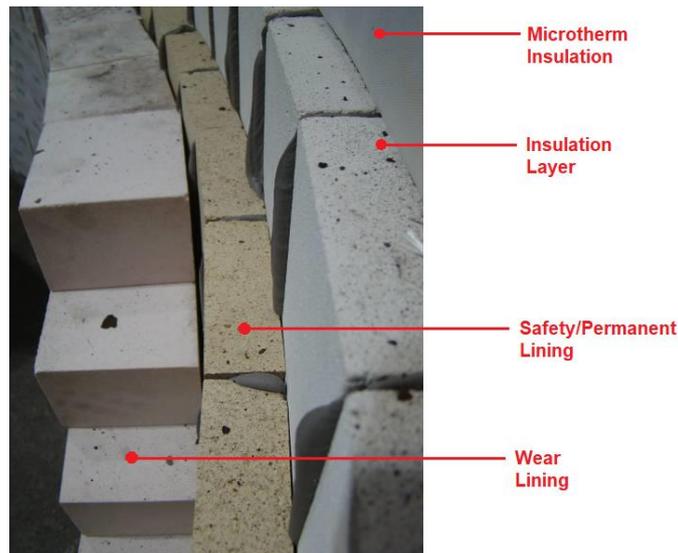
Figure 2 - Different layers of refractory linings in the steel ladle.

The refractory linings of the steel ladle are composed of three layers: the working or wear lining, the safety or permanent lining and the insulating layers (Figure 2). In general, the working linings which will be in direct contact with the molten steel and safety linings are made from refractory brick units or castables. In the case of the steel ladle used at the Tata Steel plant, IJmuiden, the working lining has dry joints (no mortar), while the safety lining is constructed using mortar joints. These layers are exposed to high temperatures (in particular, the working lining) and must resist chemical wear against molten steel and slag while sustaining its mechanical performance.

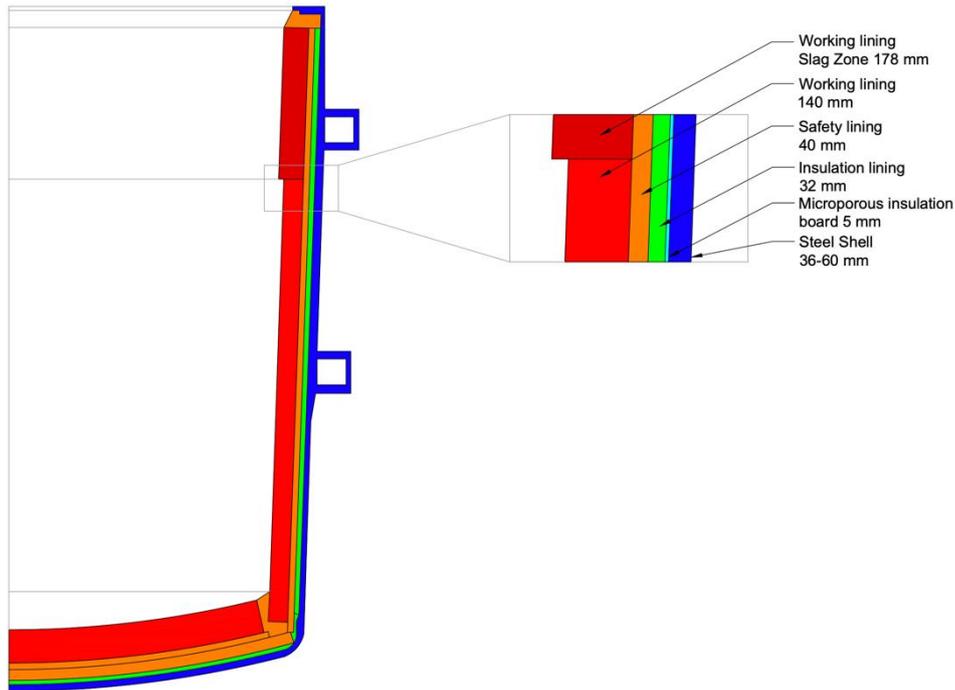
Figure 3 - Schematic of the IJmuiden steel ladle, used as the model ladle, with different parts of its refractory linings.

At the wall, the linings are composed of several layers including wear linings, permanent linings (safety lining and insulation lining), microporous insulation and a steel shell. The thicknesses of these layers are presented in the Figure 3. For the most part, these layers remain the same except for the wear lining, which is modified to correspond with the slag zone. The wear lining has a higher thickness and utilises a different refractory material to resist the chemical effects (corrosion) of the slag.

At the ladle bottom, the wear lining is composed of the same bricks but with a larger thickness (250 mm) in comparison to the wall (178 mm) and the safety lining is also larger (76 mm compared to 40 mm). These changes are necessary to withstand the harsh impact load of molten steel during the filling stage.

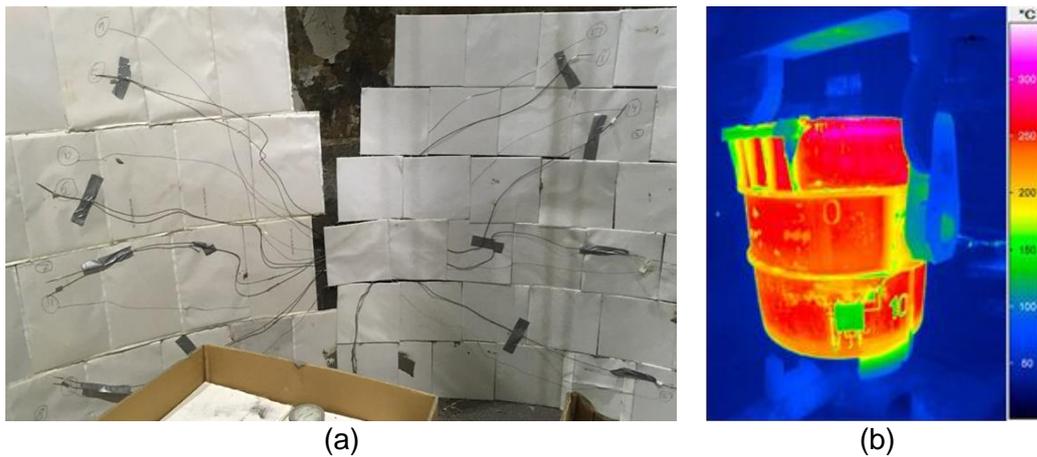
Figure 4 - Examples of thermal characterisation tools: a) thermocouples and b) infrared camera.

Thermocouples are widely used for the instrumentation of industrial devices. The most common is the K type, which is composed of Nickel-Chromium / Nickel-Alumel (nickel + aluminium + silicon alloy). This thermocouple is widely used because it is inexpensive, accurate, reliable and can operate in a wide range of temperatures, up to 1260 °C with an accuracy of +/- 2.2 °C. The thermocouples can be installed at the refractory layers (working, safety and insulation) and in the steel shell at different locations (Figure 4a). They can be installed in holes drilled into the refractory bricks or welded to steel parts.

The infrared camera is a useful tool that can measure the temperature distribution on the external surface of the steel ladle from a relatively far distance (Figure 4b). The infrared cameras present some advantages compared to the use of thermocouples. This equipment provides full field measurement of the temperatures, while thermocouples provide single-point measurements. Therefore, if the problem involves a significant gradient of temperatures or for large structures, many thermocouples would be necessary to evaluate the system, whereas only one IR camera would be required to provide all the necessary measurements on each surface. A drawback is the limitation on measuring temperatures inside the linings and between the layers, so in such cases, thermocouples are more suitable.

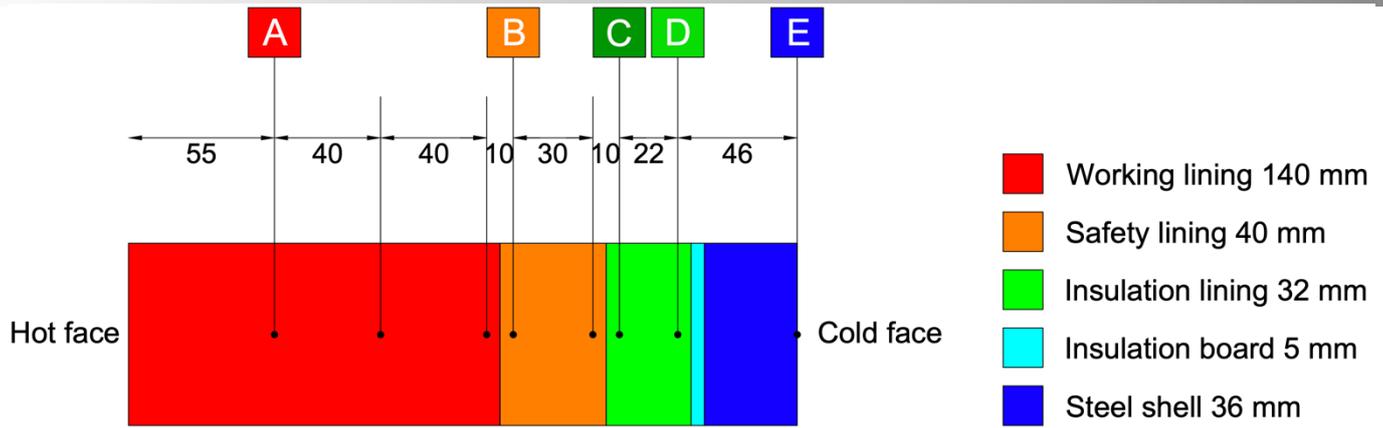
Figure 5 - Schematic of the placement of thermocouples in the refractory lining from the hot-face to the steel shell. The colour legend shows the lining type and the thicknesses. The eight embedded thermocouples are shown as black dots with their relative distances from each other indicated in mm. Data from five thermocouples, labelled A-E, are displayed in the next figure.

Figure 5 presents the graphical representation of the placement of thermocouples in a typical refractory lining of the model industrial steel ladle. From the figure, it can be seen that, at a single location of a typical lining, 8 thermocouples were used. In total, there were three locations where eight thermocouples were installed across the linings. From Figure 5, the relative location and its distance from the face of the wear lining (i.e. hot-face) can be observed. Considering the presence of the molten steel and corrosion of the wear lining, no thermocouple was installed at the hot-face of the wear lining.

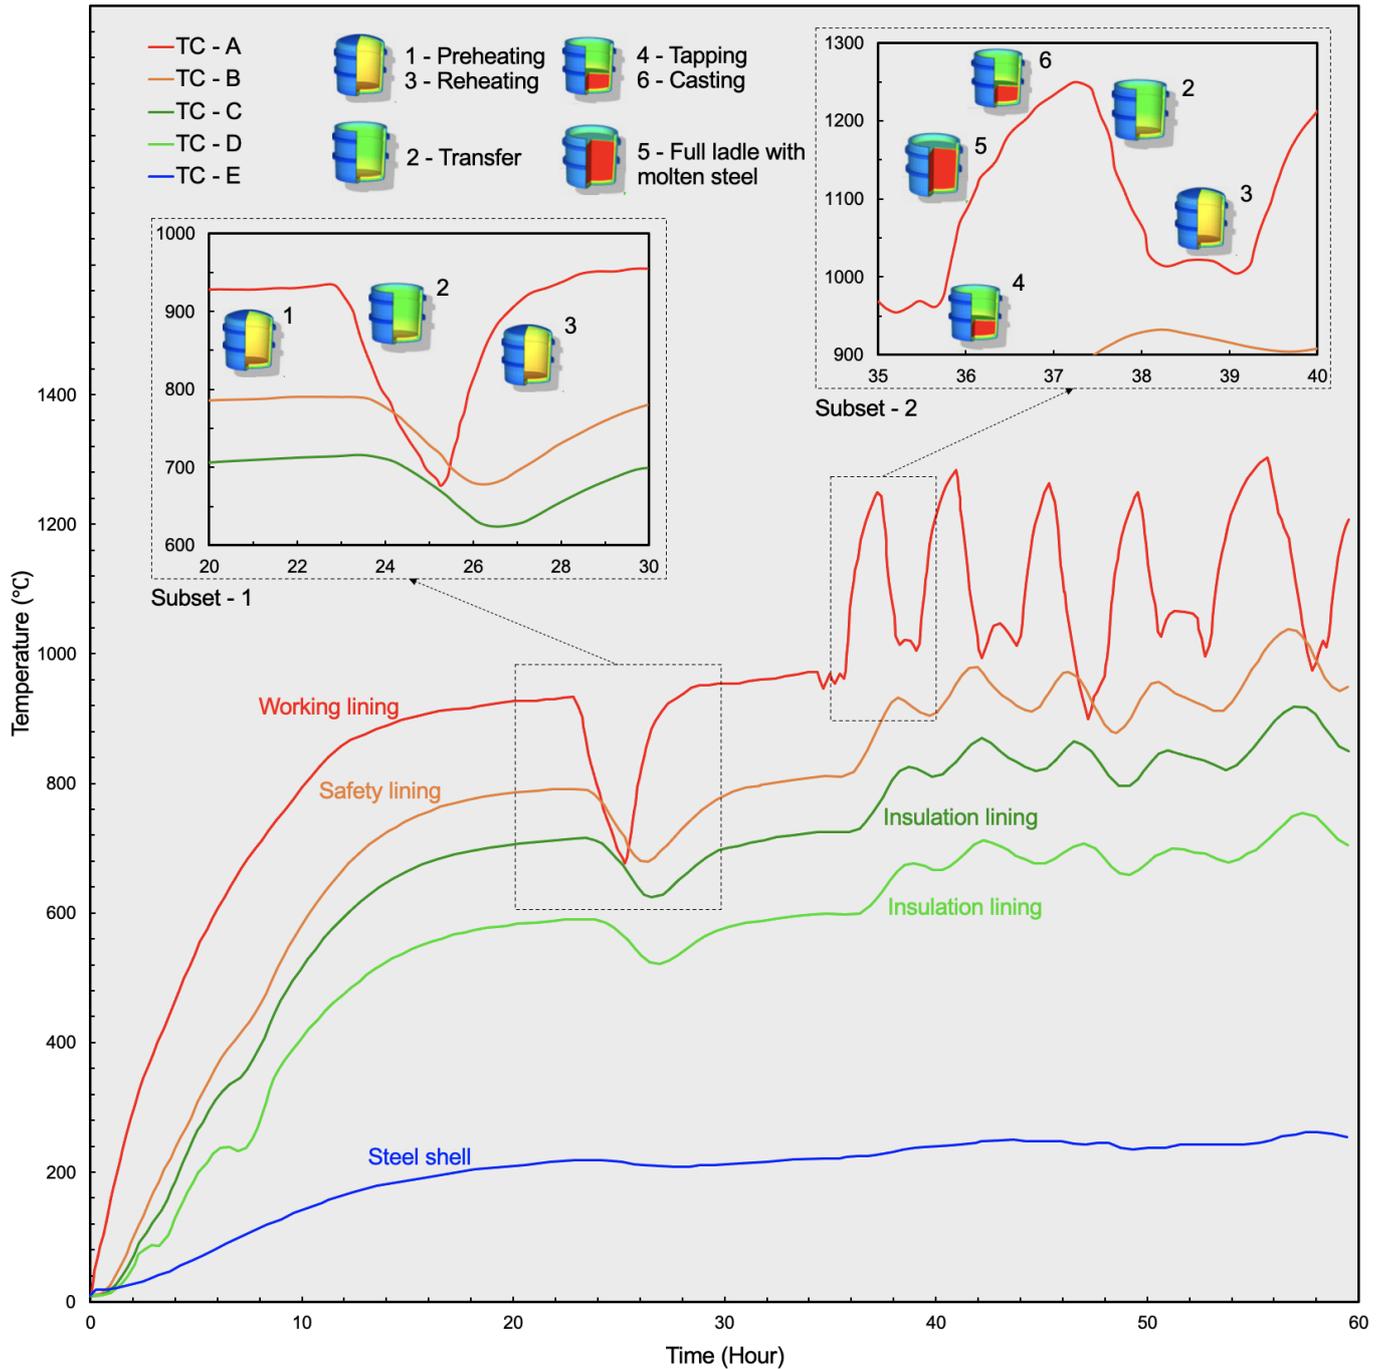
Figure 6 - Measurement results of some thermocouples in the wall of the steel ladle. The preheating stage, when the ladle is prepared for operation, and the first five loads.

The in-situ temperature measurements, acquired from thermocouples A - E embedded in a new steel ladle, were obtained during the preheating stage and the first 5 loading cycles, as shown in Figure 6. The measured temperatures, together with material, construction, and process data, give a good insight into the thermal boundary conditions such as the heat transfer of the liquid steel to the refractory linings of the steel ladle.

A newly lined ladle first undergoes a dedicated preheating period where the temperature is increased from ambient to 1050 °C with the help of gas burners over approximately 23 hours. This preheating period is represented by the picture of an empty steel ladle, fitted with a lid, in Figure 6 (Label 1 - Preheating). The lid denotes the placement of gas burners during this heating phase. Afterwards, the steel ladle is removed from the preheating pad and transferred to a waiting area (at approximately 25 hours) where it again undergoes heating with gas burners to keep the linings warm and ready for the thermal load. During the transfer from the preheating pad, represented by the ladle without a lid (Label 2 - Transfer), the ladle lining loses considerable amount of heat as can be observed from the sharp drop in temperature between 23-25 hours. After the ladle is placed in the waiting area and subjected to heating (Label 3 - Reheating, represented by an empty ladle with a lid), a sharp recovery is also noted. The ladle stays idle at the reheating pad for a period until it is transferred for the thermal load. This time varies depending on the plant management of the ladles. The thermal load for this ladle is applied around 36 hours. Before the ladle undergoes thermal loading, it is transported to the converter from the reheating pad. At the converter, the steel ladle is tapped (filled with molten steel). This

takes about 7 minutes. During this period a sharp rise in temperature can be observed (Label 4 - Tapping). Subsequently, the ladle passes through various processes before it reaches casting machines. During this period, the ladle is full of the molten steel and the temperature continues to rise in the linings (Label 5 - Full ladle with molten steel). At the casting machine, the molten steel is gradually poured out. During the casting process, a steady rise in temperature can be observed (Label 6 - Casting). This rise, despite the pouring, is due to the location of the thermocouples which were located in the lower part of the steel ladle. Thus, for most part of the casting, the lining present with thermocouples is in contact with the molten steel. Once the casting is finished, the ladle is transported for the tipping process. During this transfer, a sharp drop in the temperature can be observed (decreasing from 1250 °C to 1000 °C) represented as label 2 in subset 2 of Figure 6. This drop in temperature is due to the unprotected ladle subjected to natural convections from steel shell and refractory working lining. Ultimately, the ladle is transferred to the heating pad to ensure the ladle is ready for other thermal loads (Label 3 - Reheating).

It can be observed that, between the unloading phase and the next load cycle, the temperature fluctuates due to transportation of the ladle from the tipping process to the reheating pad at the waiting area. After the first thermal load and the subsequent loads, it can be observed that the temperature at the working lining (Thermocouple A) varies by around 50 °C (increasing in 2nd load, decreasing in 3rd and 4th load and increasing again in 5th load). This change in temperature can be explained by the fact that the temperature of the molten steel is slightly different between each loading.

The highest temperature measurements and most dramatic changes in temperature are recorded by thermocouple A. This is expected as it is located in the working lining, 55 mm from the hot-face. The temperature increase observed in the new steel ladle, from the gas burners during the preheating period, is from room temperature (20 °C) to around 950 °C (Figure 6). The temperature that was expected to be observed at the surface of the refractory brick was 1050 °C. As the thermocouple A is located at the centre of the wear lining, the temperature observed at that location is lower compared to the applied temperature. The sudden drop and increase in temperature, during the transfer from the preheating pad, corresponds to loss and subsequent gain of 240 °C. The changes in temperature observed for the loading and unloading are of the magnitude of 250 °C during the normal thermal cycles (as observed after 1st, 2nd and 4th load cycles). It can be observed that the drop in temperature is larger after the third and fifth cycles (around 350 °C), this is due to the fact that, after those loads, the ladle was not subjected to the reheating due to plants' ladle management activities.

Thermocouple B, 145 mm from the hot-face and 90 mm from A, is located at the face of the safety lining closest to the hot-face. An approximate decrease in temperature of 120 °C is observed, in comparison with thermocouple A. The sudden changes in temperature observed for A are still observed, however, the intensity of the changes are reduced by approximately half.

Thermocouple C, located 185 mm from the hot-face and 40 mm from B, has been inserted in the insulation lining near the joint between safety and insulation lining. The data shows a similar pattern to that observed for B with a global reduction in temperature of approximately 80 °C.

Thermocouple D, located 207 mm from the hot-face and 22 mm from the C, is located at the insulation lining near the microporous insulation board. The data presents a larger global reduction in temperature (120 °C) between C and D than observed between B and C, even though the distance between them is approximately half that between B and C, as a result of the insulating material. During the preheating period, two plateaus can be observed, first at 100 °C and later at 240 °C. This thermocouple is located close to a mortar layer between the brick and insulation board. The first plateau is due to the evaporation of free water at 100 °C between 2 and 4 hours. The 2nd plateau observed around 240 °C can be due to the removal of chemically bound water from the mortar layer.

Thermocouple E, located 46 mm from the cold-face of the ladle (36 mm of which are the steel shell), records a global drop in temperature of 400 °C. This significant drop in temperature demonstrates the effectiveness of the 5 mm of microporous insulation board present between thermocouples D and E.

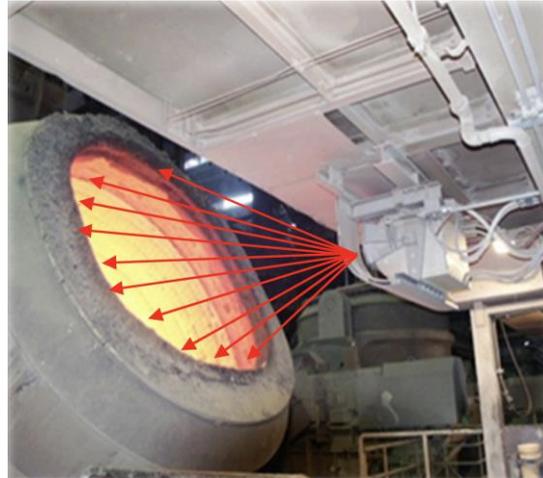
Figure 7 - Example of laser scanner measures from outside position [5].

ingress of molten steel into the linings, damaging the steel shell. A failure during a crucial production process can stop the production line, leading to significant economic consequences, hence continuous monitoring of the ladle is undertaken. Measurement of the wear can be done indirectly or directly. Indirect measurement can be performed with the help of thermal measurement in the working lining. However, these indirect measurements are only taken for a point where the thermocouples are located and are not representative for the whole working lining. To measure the overall distribution of the wear of a lining, a direct measurement with Terrestrial Laser Scanners (TLS) can be used. TLS, or 3D scanning, may be used to evaluate the geometry of the steel ladle. This equipment was originally developed for as-built modelling of architectural and engineering structures; however, they can also be used for high-resolution mapping of industrial vessels and equipment (Figure 7). Laser scanning can also be used to measure temperature. Some systems are also able to measure the reduction of the thickness of the linings, as bricks are continuously subjected to corrosive attacks by hot liquid steel and slag. The laser scanner measurements can be used to evaluate the variation of thickness of the bricks in hot conditions by sending infrared laser pulse from outside the ladle to the wall and the bottom.

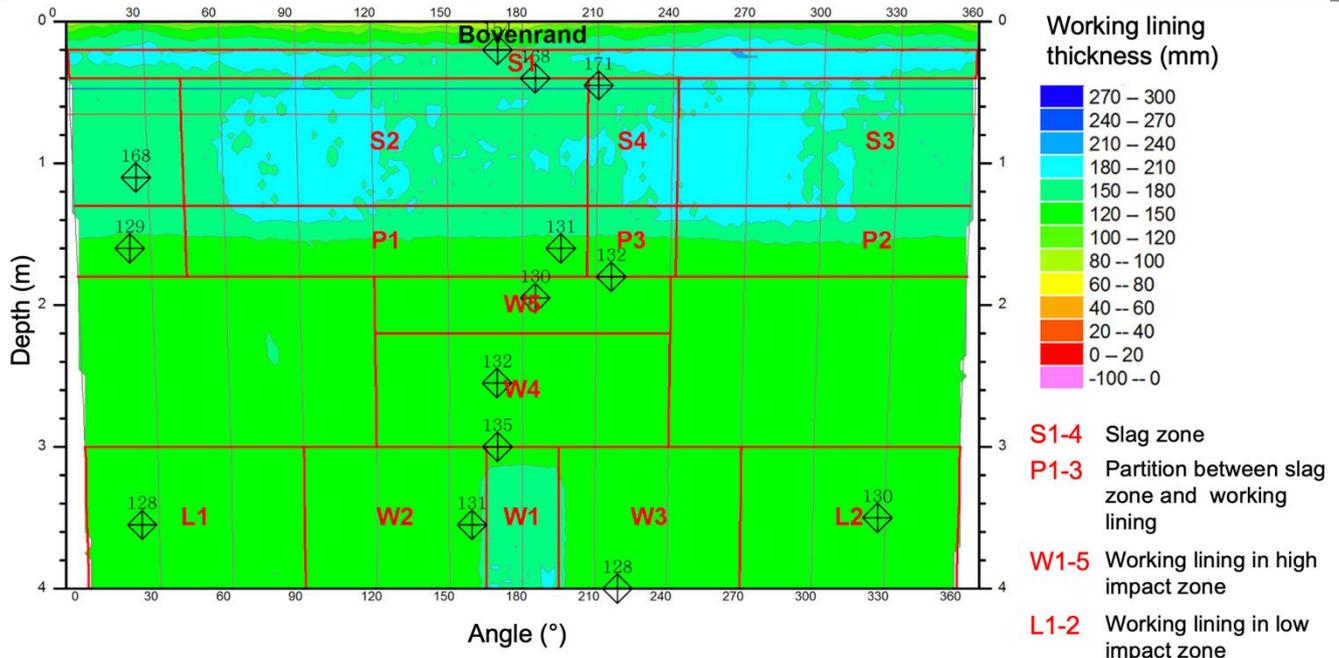
Figure 8 - Example of the working lining thickness distribution, of a newly lined steel ladle, calculated from the laser scans (taken between the inside measured point and a reference point on the inside of the safety lining). The legend shows the calculated thickness of the working lining in mm. Zones S, P, W and L indicates different zones of interest.

Figure 8 presents an example of an immersed laser scan taken on a newly lined steel ladle at TATA Steel, The Netherlands. This scan shows the circumferential layout for the thickness of the working lining. From this initial scan and a set reference point on the exterior steel shell of the ladle, different thicknesses in the working lining can be identified with the help of CAD drawings. The average thickness in the lower part of the lining is 140 mm and the thickness in the upper part is 180 mm (Slag zone). These values are similar to the values described in the ladle design (Figure 3). Different zones shown in Figure 8 indicate area of high interest for the wear in the working lining. Zone S 1-4 are in the slag line of the working lining. S1 represents the upper-most part of slag line near the opening of ladle. S2-3 are in the slag line. Zone P 1-3 represents the partition, a boundary zone between the slag line with 180 mm thickness and working lining with 140 mm thickness. Zone W 1-5 are in the working lining and located in the zone near the impact pad. The impact pad in working lining is marked by zone W1. This area has higher thickness of 178 mm to withstand repetitive impact during thermal loadings. The areas near W1 are marked by W2-5. Zone L 1 and 2, represents a low impact zone in the working lining. In this area, not much wear is expected in usual service conditions.

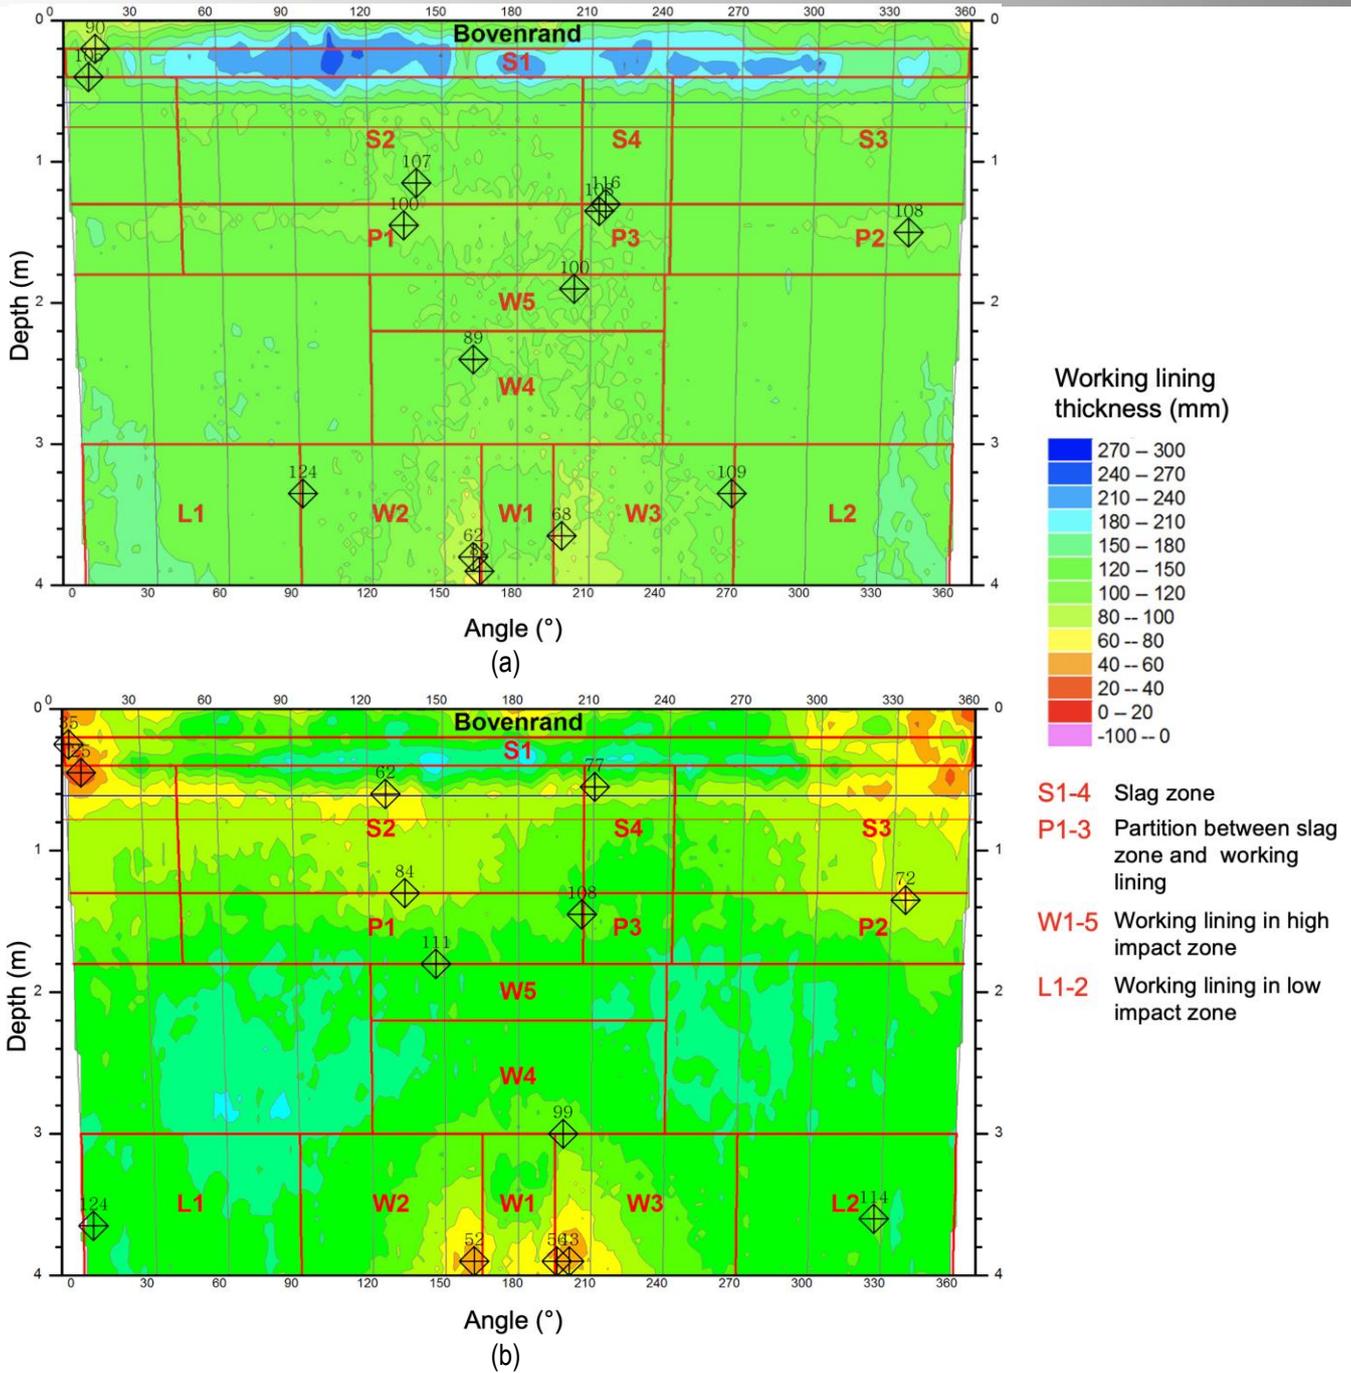
Figure 9 - Example of working lining thickness distribution on steel ladle after thermal loadings calculated from the laser scans: a) after half life cycle and b) after full life cycle.

Figure 9 presents examples of laser scans performed at two different instances during the full life cycle of the working lining. Figure 9a indicates the distribution of the wear at half life cycle of the working lining and Figure 9b at full life cycle. A comparison between the initial scan (Figure 8) and Figure 9a shows the range of wearing. It is possible to observe wearing of 30 mm in the slag zone (marked as S2-4 and P 1-3). However, at the same instance, an increase in thickness can be observed at the upper part of the ladle (S1). This is the area where slag starts to accumulate after thermal loads.

Figure 9b presents the distribution at full life cycle after which the linings need to be replaced. From this figure, it can be observed that the working lining in the slag zone is reduced to 80 mm (from 178 mm) due to wear. Also, a reduction in the upper part can also be observed (S1) which indicates the manual removal of the accumulated slag with mechanical equipment.

From both these scans, it is possible to observed that the working lining located in the slag zone undergoes rapid wear compared to rest of the lining. This is to be expected as contact with slag creates severe corrosion that promotes rapid wear. It is interesting to note that, in this Ijmuiden steel ladle, the life cycle of working lining is governed mainly by the slag zone lined with Magnesita Carbon bricks. The working lining area, that rests in contact with the molten steel, is lined with alumina spinel bricks which also undergoes wear, but the magnitude is much smaller. The areas most affected by the wear in the lower parts are shown in zone W1-3 in Figure 9a-b. The localised wear can be due to the repetitive impact generated by molten steel while being loaded.

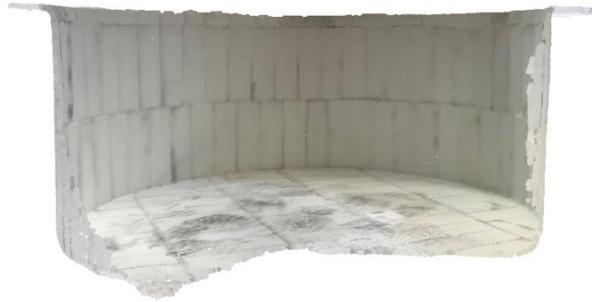
Figure 10 - Example of photogrammetry (lining of Pilot steel ladle).

Photogrammetry is the process of generating 3D models from a series of images of the object; the resulting model can be scaled and used to measure distances between objects and to measure the deformed configuration of some structures. This technique provides reliable, low-cost measurements [7]. Figure 10 presents an example of photogrammetry applied in the case of the pilot steel ladle. With this technique, it is possible to gather cloud points which can be reconstructed into a 3D graphics. This can be useful to obtain the overall geometry of a large structure or to observe any changes in the structure over time (in terms of displacement).

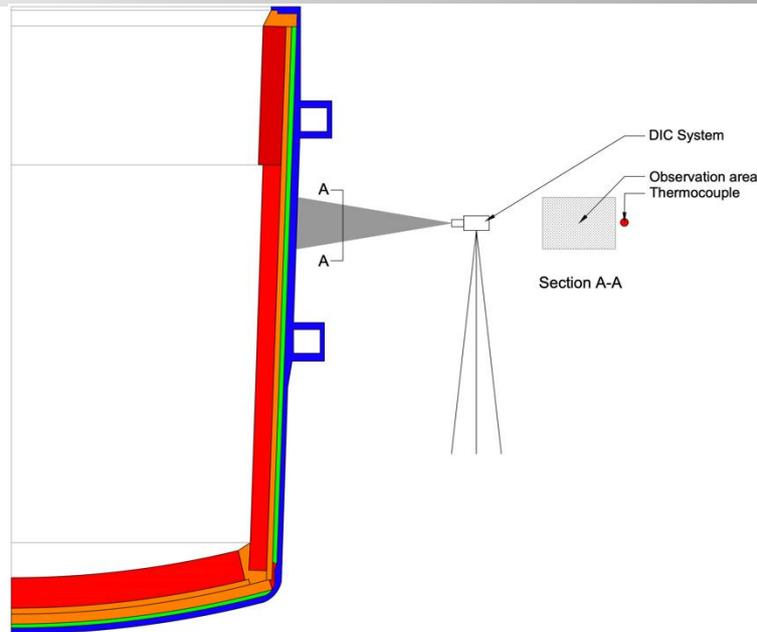
Figure 11 - Proposed DIC measurement layout.

Figure 11 presents the proposed DIC measurement layout. For this, a representative 'observation area' on the outer side of the steel shell of the ladle will be selected. After cleaning the observation area, a suitable speckle pattern will be applied with paint. Next to the observation area, one thermocouple will be installed to measure the temperature during the period of the preheating. Due to safety regulations, this thermocouple will be attached to steel shell with magnet. During this measurement, the inside temperature will be recorded using the thermocouple present inside the steel ladle for the control of the temperature during the preheating process.
