Deliverable D 2.2 Report about fundamental corrosion mechanisms and influencing factors

Document type	Deliverable D 2.2
Document Version / Status	2.2
Primary Authors	Jacek Szczerba, jszczerb@agh.edu.pl, AGH, Ryszard Prorok rprorok@agh.edu.pl, AGH
Distribution Level	PU (Public)
Project Acronym	ATHOR
Project Title	Advanced THermomechanical multiscale mOdelling of Refractory linings
Grant Agreement Number	764987
Project Website	www.etn-athor.eu
Project Coordinator	Marc Huger, <u>marc.huger@unilim.fr,</u> UNILIM
	Jacek Szczerba, <u>iszczerb@agh.edu.pl</u> , AGH
	Ryszard Prorok <u>rprorok@agh.edu.pl</u> , AGH
Document Contributors	Camille Reynaert, <u>reynaert@agh.edu.pl</u> , AGH
	Sina Darban, <u>darban@agh.edu.pl</u> , AGH
	Glyn Derrick, <u>glyn.derrick@unilim.fr</u> , UNILIM

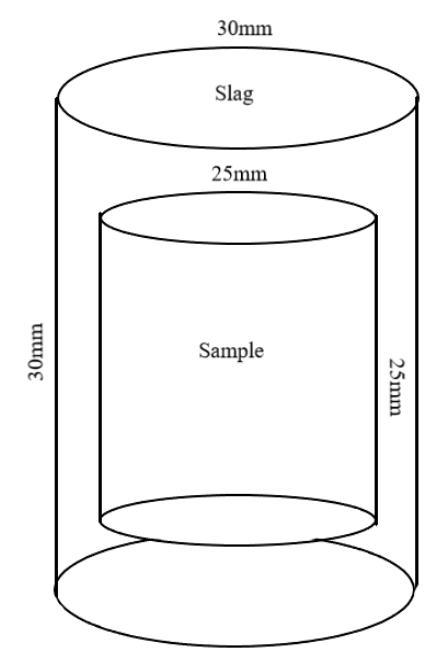
Figure 1: Schema of refractory sample pressed with slag pellet.

To prepare the alumina-spinel samples for the corrosion test, first the alumina-spinel brick was cut and drilled into a circular shape (d=25 mm, h=25 mm), then dried for 24h at 150 °C. Next, the sample was incased in slag using a hydraulic press as shown in Figure 1 then positioned in a graphite crucible. The corrosion test was conducted with the standard slag and the modified $10SiO_2$ slag, at 1350 °C for 10 and 30 hours.

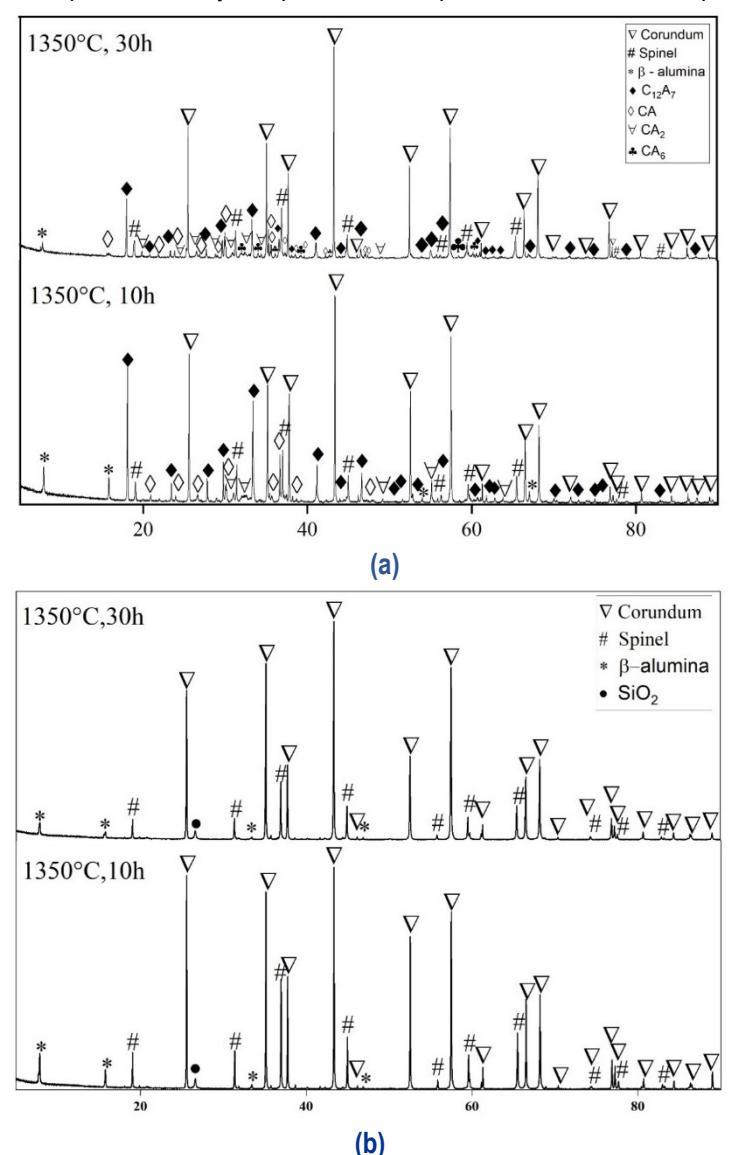
Figure 2: XRD patterns of corroded Al-1-1 and Al-1-2 alumina-spinel samples with standard slag (a) edge part of the samples, and (b) core part of the sample.

Figure 2(a) shows the phase composition analysis of the edge of Al-1-1 (1350 °C - 10h) and Al-1-2 (1350 °C - 30h) samples, respectively. Mayenite (C₁₂A₇) peaks are present in both XRD patterns (AI-1-1 and AI-1-2) which is due to remnants of slag on the edge parts after cooling, due to partial slag's infiltration. By prolonging the dwell time to 30h, the intensity of the mayenite (C₁₂A₇) peaks decreased, as a result of higher infiltration and less remained slag.

Furthermore, Figure 2(a) shows the presence of calcium aluminates like calcium monoaluminate (CA), calcium dialuminate (CA₂) and calcium hexaluminate (CA₆). This indicates that, not only did the slag infiltrate into the alumina-spinel sample, but that it also reacted chemically, leading to the formation of some minor new phases in the edge parts. Peaks, belonging to the calcium monoaluminate (CA) and calcium dialuminate (CA₂) phases, can be observed forming after 10h and those associated with a calcium hexaluminate phase (CA₆), are present after 30h. It can therefore be inferred, due to the observed differences between 10 and 30h, that the slag could not reach the equilibrium condition even after 10h.

Figure 2(b) shows the XRD pattern from the core region of Al-1-1 (1350 °C - 10h) and Al-1-2 (1350 °C - 30h), respectively. Corundum (Al₂O₃), spinel (MgAl₂O₄), beta-alumina (Na₂Al₂₂O₃₄), and silica (SiO₂) phases are present in both samples and there

is no peak of mayenite, calcium aluminates or other new phases. Therefore, it can be concluded that there was no reaction between the slag and the alumina-spinel refractory sample in the core part of the corroded samples after 10 and 30h.

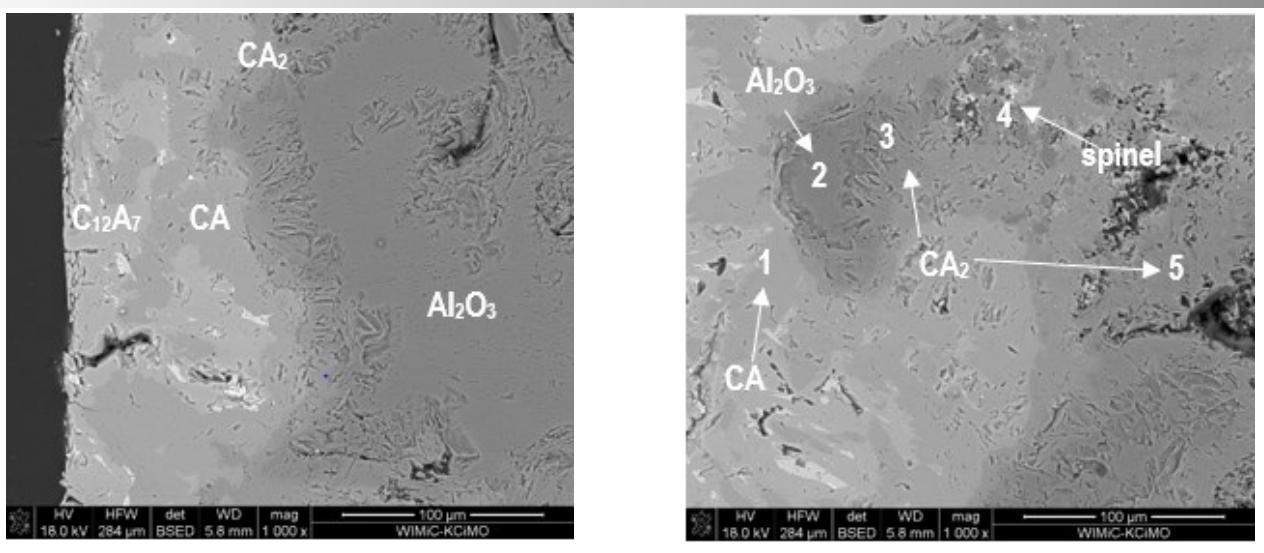
Figure 3: SEM micrographs of Al-1-1 sample corroded at 1350 °C, for 10h, showing phases present in a) the edge of the sample, and b) the core of the sample.

The overview SEM image of the edge and core part of the Al-1-1 (1350 °C - 10h) is shown in Figure 3(a) and (b), respectively. Figure 3(a) shows that mayenite ($C_{12}A_7$), calcium monoaluminate (CA) and calcium dialuminate (CA₂) are observed on the edge part of the Al-1-1 sample. Although the slag has reacted with alumina grains, there are still fine spinel grains which remain unreacted in the matrix phase. Figure 3(b) shows the SEM overview of the core part of Al-1-1 sample, some calcium monoaluminate (CA) is observed in the matrix and calcium dialuminate (CA₂) around alumina grains. Some unreacted spinel phase was also observed as fine grains in the matrix.

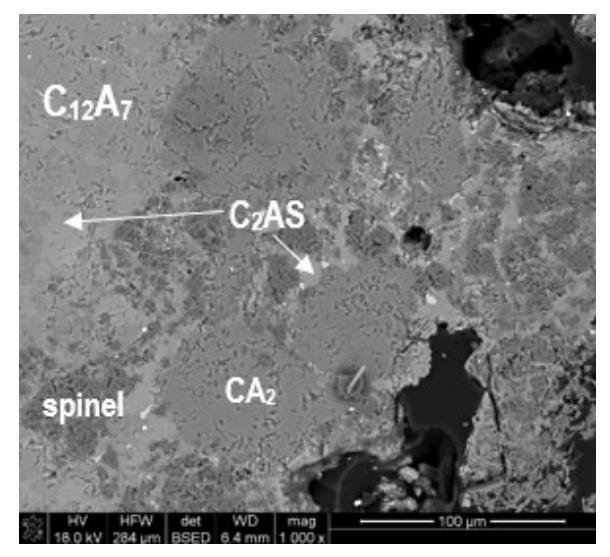
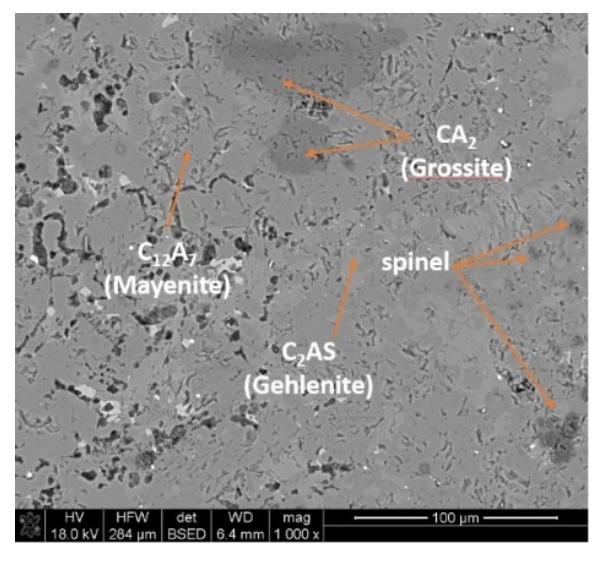
Figure 4: SEM micrographs of Al-1-2 sample, 1350 °C, 30h showing phases present in a) the edge of the sample, and b) the core of the sample.

Figure 4(a) and (b) show the SEM micrographs of the edge and core part of Al-1-2 sample, respectively. Mayneite ($C_{12}A_7$), calcium dialuminate (CA_2), spinel, and gehlenite (C_2AS) are present in the edge and core parts of the sample. This result confirms the phase composition analysis and shows that the remaining slag (mayneite) on the right side of the Figure 4(a) and gehlenite (C_2AS) among fine spinel grains in the matrix. Moreover, there are some accumulated calcium dialuminate (CA_2) from the reaction of alumina (from refractory side) and calcium dioxide (from slag side).

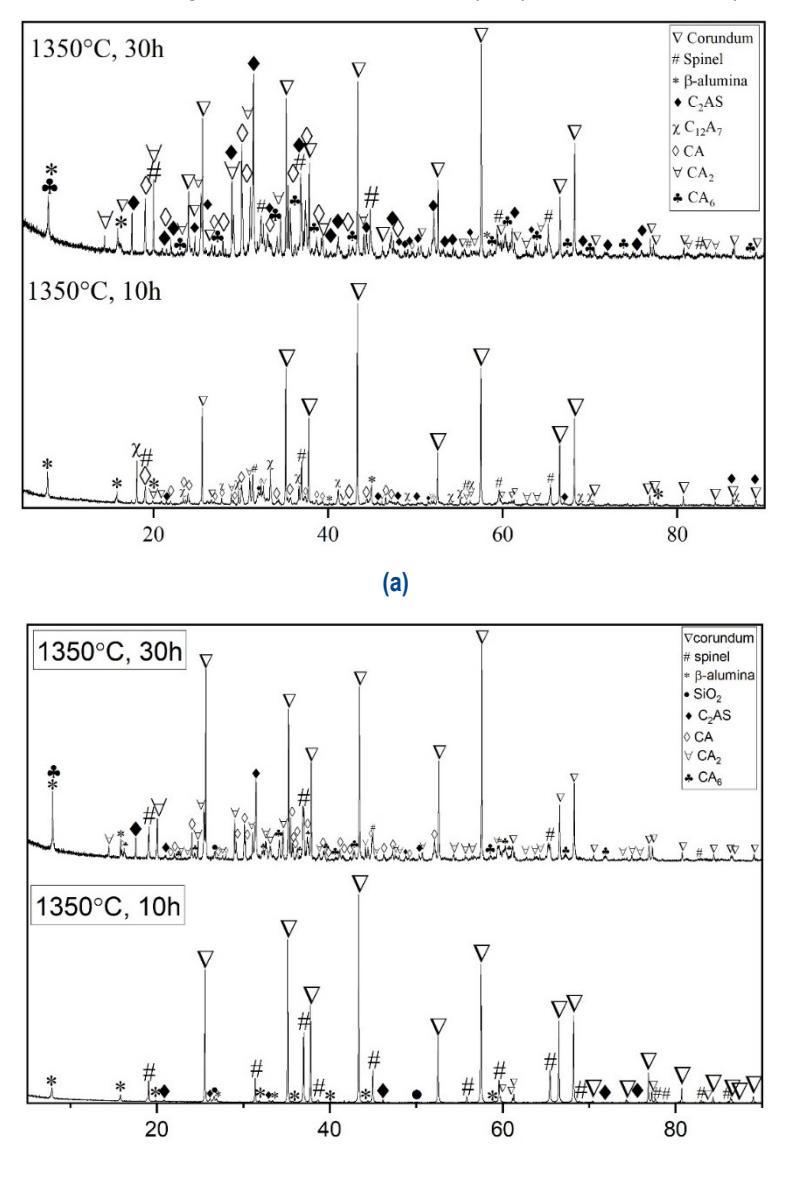
Figure 5(a) shows the edge part's XRD pattern of Al-2-1 (1350 °C - 10h) and Al-2-2 (1350 °C - 30h) corroded by slag modified with silica (10SiO₂). After 10h, the mayenite ($C_{12}A_7$), CA, and CA₂ are present. Additionally, a small amount of calcium alumina silicate (gehlenite (C_2AS)) is present. By extending the time to 30h, the amount of the gehlenite phase is increased, and the CA₆ phase peaks appear in the XRD pattern. Fig.5(b) shows the core part's XRD pattern of Al-2-1 (1350 °C - 10h) and Al-2-2 (1350 °C - 30h) corroded by 10SiO₂. Gehlenite (C_2AS), which was not observed after 10 hours of corrosion with the standard slag, is

present in the XRD pattern after 10h of corrosion with $10SiO_2$. Though, after 30h, the gehlenite phase and calcium aluminate phases were also observed in the core. This may show that silicon dioxide might facilitate slag penetration. Also, the peak intensity in 7.85° has increased due to the overlapping of calcium hexaluminate (CA₆) and beta-alumina (Na₂Al₂₂O₃₄) peaks at this point.

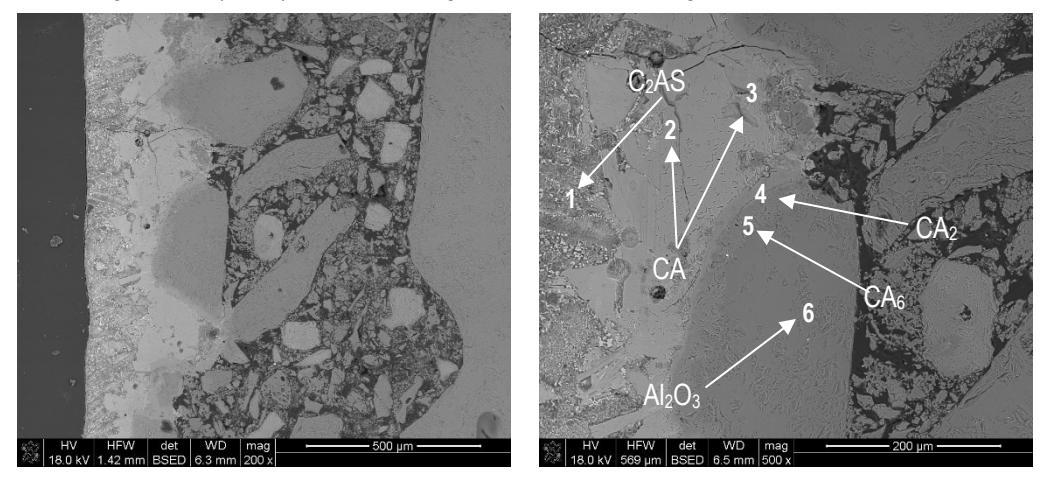
Figure 6: SEM micrographs of corroded alumina-spinel - 10SiO₂ slag (1350 °C - 10h) (a) edge part and (b) core part of the sample.

Figure 6(a) and (b) illustrate the overview SEM pictures of the edge part of Al-2-1 sample corroded with $10SiO_2$ after 10h. The present calcium aluminate phases are calcium monoaluminate (CA), calcium dialuminate (CA₂), and calcium hexaluminate (CA₆), as well as calcium alumina silicate (C₂AS). The difference between the formed phases in the microstructure of corroded samples with standard slag (Al-1-1 and Al-1-2) and $10SiO_2$ slag (Al-2-1 and Al-2-2) is the presence of calcium hexa-aluminate (CA₆) alongside coarse alumina grains at 1350 °C, after 10h corrosion, as well as presence of calcium aluminium silicate. This could point out that silicon dioxide addition to the slag composition may accelerate the reactions between Ca⁺² and Al⁺³ within the microstructure.

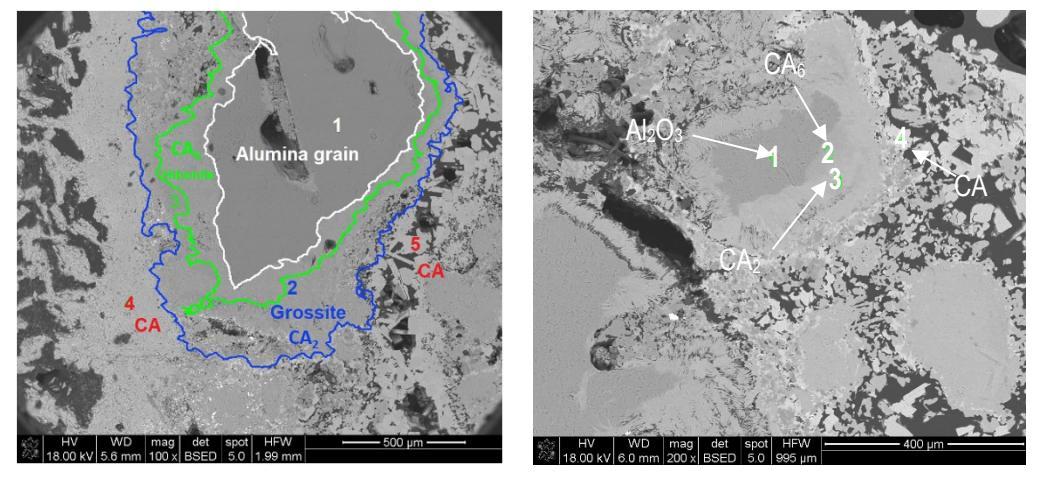
Figure 7: SEM micrographs of corroded alumina-spinel - 10SiO₂ slag (1350 °C - 30h) (a) edge part of the sample, and, (b) core part of the sample.

Figure 7(a) and (b) shows an SEM overview image of the edge and core parts respectively, of the Al-2-2 sample, corroded by $10SiO_2$ slag after 30h. It seems that the matrix is fully corroded, and there is no distinguishable barrier between corroded and un-7 / 18

corroded areas which was present in Figure 6. The sample microstructure is full of calcium aluminate phases like CA, CA₂, and CA₆. The noticeable difference that should be mentioned about this sample is that the edge parts were completely corroded, and the centre of the sample was corroded and changed considerably. According to Jia et al. [3], calcium aluminum silicate called gehlenite (C₂AS) has a pore self-forming behaviour which happens between 900-1450 °C. This characteristic may encourage abnormal expansion during the sintering process of gehlenite. Hence, the higher slag impregnation may relate to this pore self-forming behaviour of the gehlenite (CA₂S) phase inducing further micro-cracking in the local infiltrated microstructure.

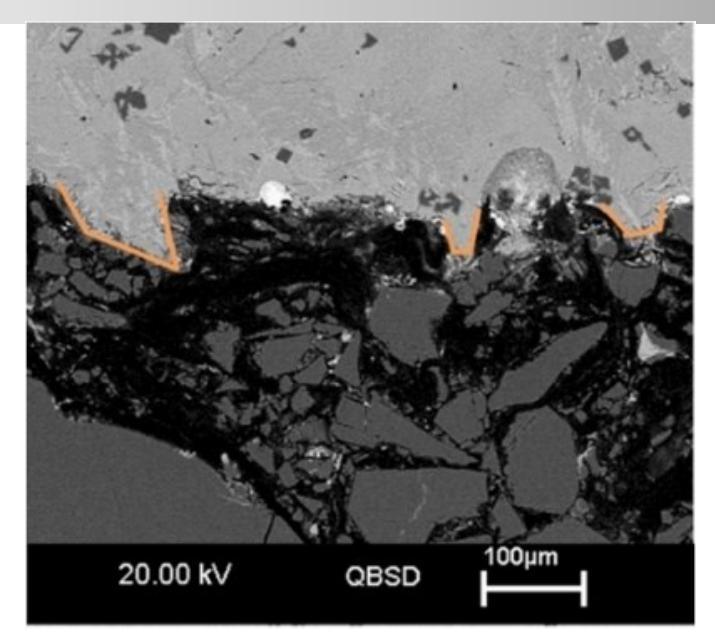
Figure 9: Pitting (indicated in orange) in the shape of MgO grains at the interface between MgO-C brick and slag.

In Figure 9, pitting, in the shape in the MgO grains (indicated by orange lines), can be observed. Looking more locally at the interface between the MgO grains and the slag, the surface of the MgO grains is irregular, as can be seen in Figure 10a) and Figure 11a), b) and c). Looking at the slag side, the formation of many MgO dendrites can be seen, which suggests that the amount of MgO in the slag has increased. All of these observations suggest that the MgO has been dissolved by the different types of slag.

In all samples, MgO is dissolved, as indicated by the pitting observed in Figure 9, as well as the irregular surface of the MgO grains and the presence of MgO dendrites in the slag in Figure 10, Figure 11 and Figure 13. The dissolution of MgO is diffusion controlled [11,18,19], hence the dissolution of MgO in the slag can be described by the Noyes-Nernst's equation Equ. 6 and Equ. 7 for static diffusion (the experiments performed were static tests) [11].

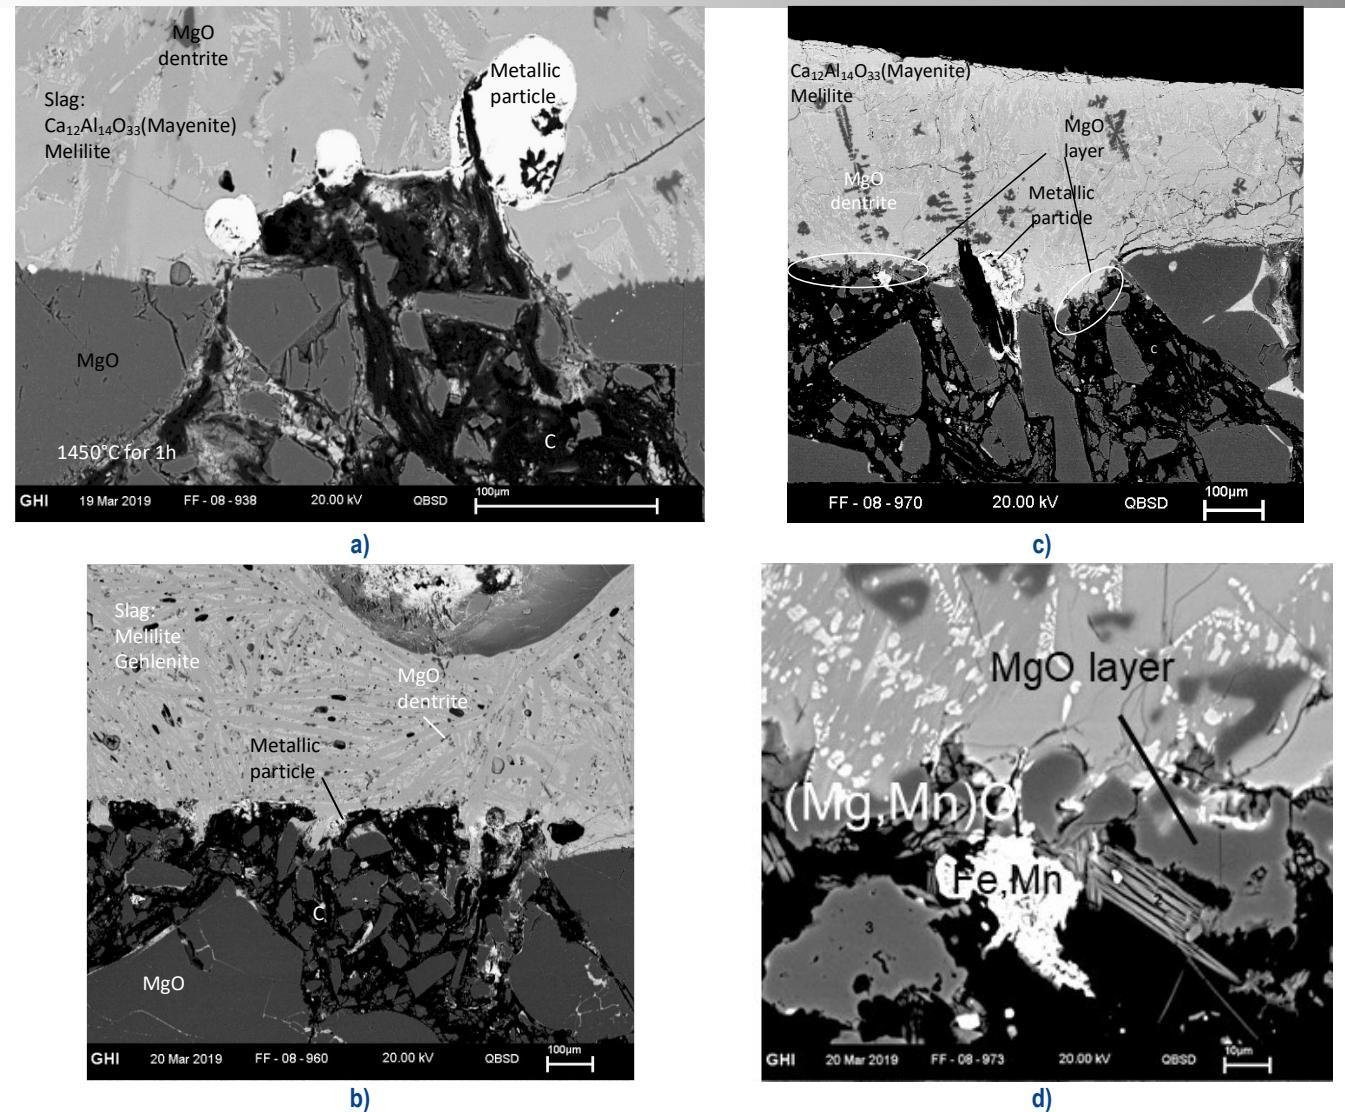
Figure 10: Micrographs of the MgO-C bricks after corrosion with the contact test in a reducing atmosphere at 1450 °C using a) standard slag, b) 10SiO₂ slag, c) 10 MnO slag and d) a zoom of the magnesia layer (10MnO slag).

Moreover, metallic droplets are present on the surface of the bricks. They are composed mainly of Fe for the samples corroded by the standard or the $10SiO_2$ slag, and Fe and Mn for the samples corroded using the 10MnO slag. An MgO layer is observed on the surface of the sample corroded using the 10MnO slag at 1450 °C and 1550 °C, as shown in Figure 10c) and d) and Figure 11c) and d). The carbon matrix has also been slightly oxidized as indicated by the decarburized area shown in Figure 11. These observations, combined together, indicate a carbothermic reaction between the carbon matrix and MgO.

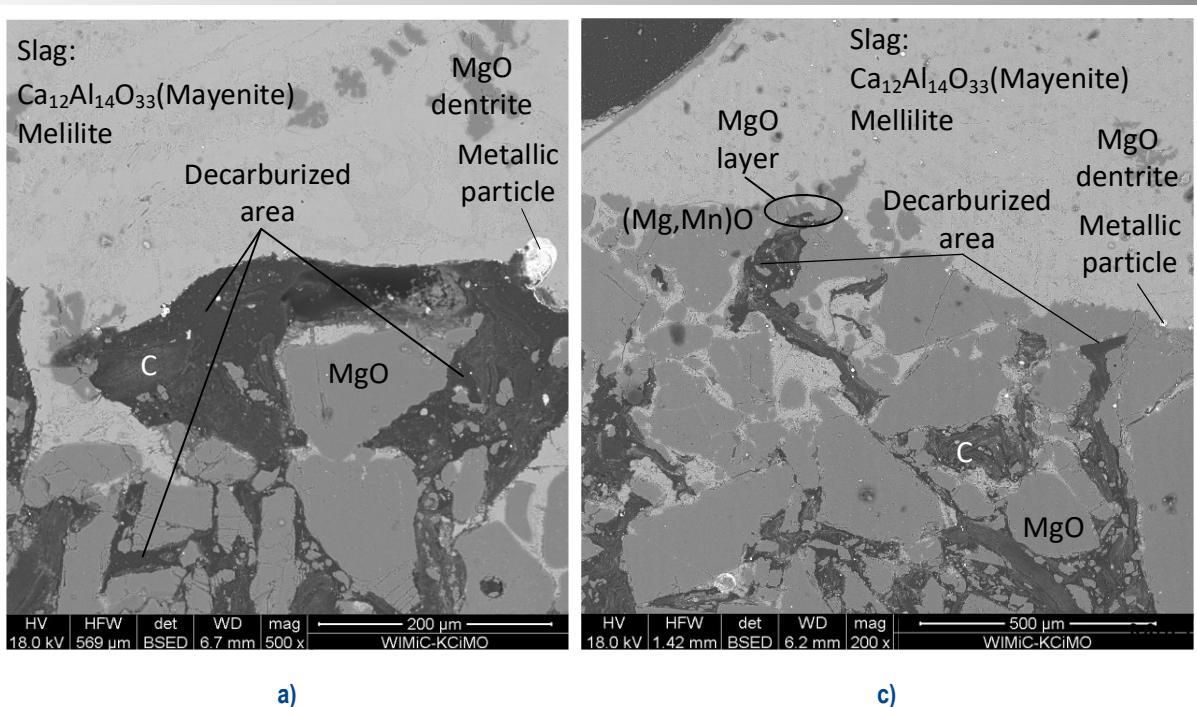
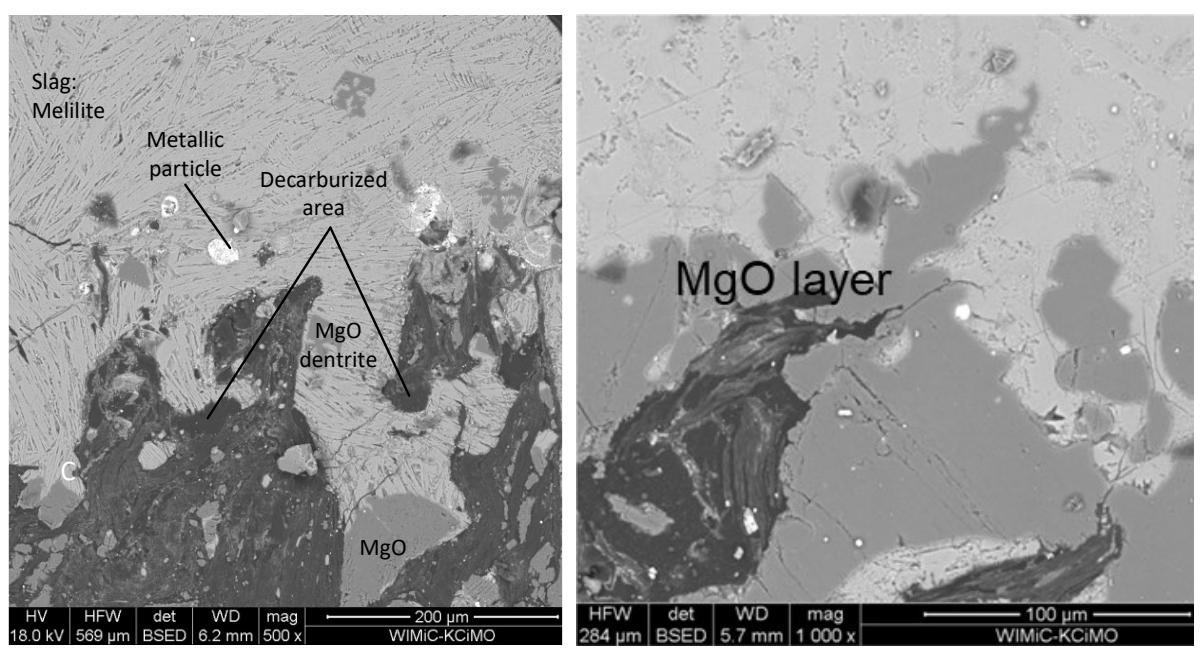
Figure 11: Micrographs of the MgO-C brick after corrosion with the contact test in a reducing atmosphere at 1550 °C using a) standard slag, b) 10SiO₂ slag, c) 10 MnO slag and d) a zoom of the magnesia layer (10MnO slag).

The samples corroded at 1450 °C and 1550 °C appear mostly similar but the sample prepared at 1550 °C appears to have been corroded to a greater extent as more slag can be observed behind the slag/MgO interface, as shown in Figure 11.

The first phenomenon responsible for the corrosion of the MgO-C brick is the oxidation of the carbon from the matrix. The oxidation occurs at the interface of the sample, as indicated by the decarburized area, the presence of metallic droplets of Fe or Fe-Mn at the brick/slag interface observed in Figure 10, Figure 11 and Figure 13 and the formation of an MgO layer in the sample corroded

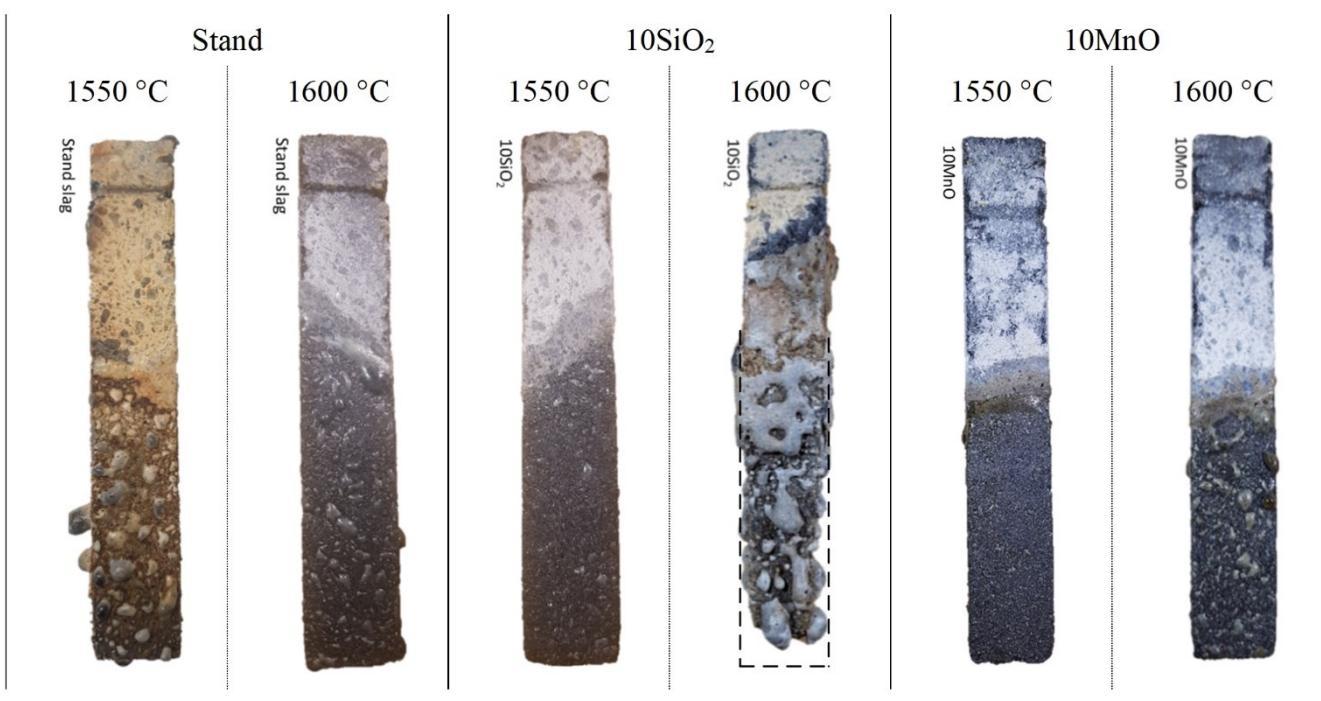
Figure 12: Pictures of the corroded MgO-C samples obtained with the dipping test under an argon atmosphere at 1550 °C and 1600 °C using the 3 slags.

The second test performed was the dipping test. First, the corrosion of the samples using the standard and the 10MnO slag was low at both temperatures, no difference in the width could be measured. For the samples corroded using the $10SiO_2$ slag, the corrosion was low at 1550 °C and higher at 1600 °C: the sample lost about a third of its width, as is observed in Figure 12.

This equation indicates that the dissolution of MgO depends on C_{sat} of the slag. It can explain why the MgO layer is only visible in the samples from the pellet test and why the sample corroded using the $10SiO_2$ slag is corroded to a greater extent, as seen in Figure 12.

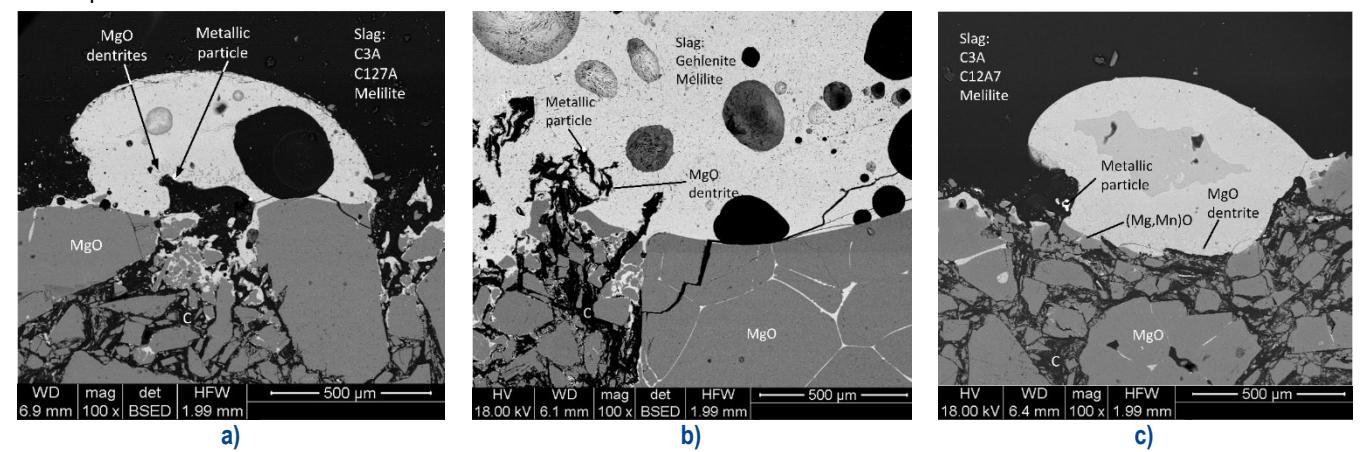
Figure 13: Micrographs of MgO-C samples obtained after the dipping test under argon atmosphere at 1600 °C for 1h using a) standard slag, b) 10SiO₂ slag and c) 10MnO slag.

The microstructure of the samples from the dipping test observed by SEM are mostly similar to those observed in the previous test. MgO is partially dissolved into the slag as show in Figure 13 Metallic particles of Fe for the sample corroded using the standard and 10SiO₂ slags and Fe and Mn for the samples corroded by the 10MnO slag are present at the surface of all the bricks. A small amount of carbon is oxidized and replace by the slag. The only difference is the absence of the MgO layer in all the samples.

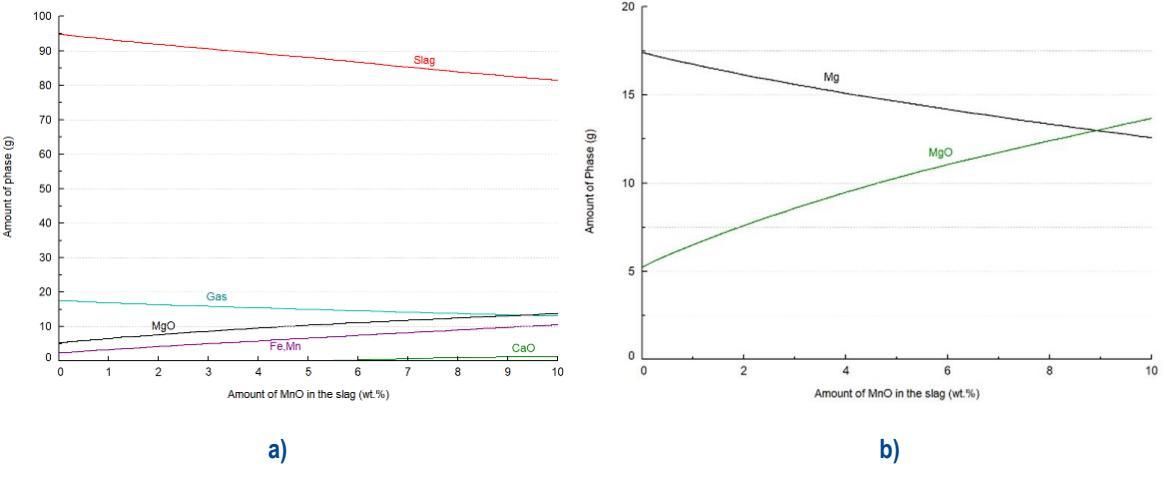
The amount of Mg gas that can be oxidized when the amount of MnO increases in the slag was examined qualitatively by performing thermochemical calculations with Factsage. The Factsage calculations were performed with the Equilib module by inputting 20 g of Mg gas and 100 g of slag with increasing MnO content. The results are presented in Figure 14.

The quantity of Mg gas that can be re-oxidized by the slag and form the MgO layer, increases when the quantity of MnO in the slag increases. This is suggested by the parallel increase of MgO, Mn and Fe in **Error! Reference source not found.**a). Indeed, Equ. 4 and Equ. 5 indicate that metallic Fe and Mn form as the result of the oxidation of Mg gas by the slag. Moreover, Figure 14b) indicates that the quantity of MgO increases as the quantity of Mg gas decreases, which again suggests that increasing the amount of MnO in the slag leads to greater MgO layer formation. However, if the formation of the MgO layer is the only phenomena taking place, the MgO layer should also be observed in the sample from the dipping test. Hence another degradation phenomenon is taking place in the sample, the dissolution of MgO in the slag.

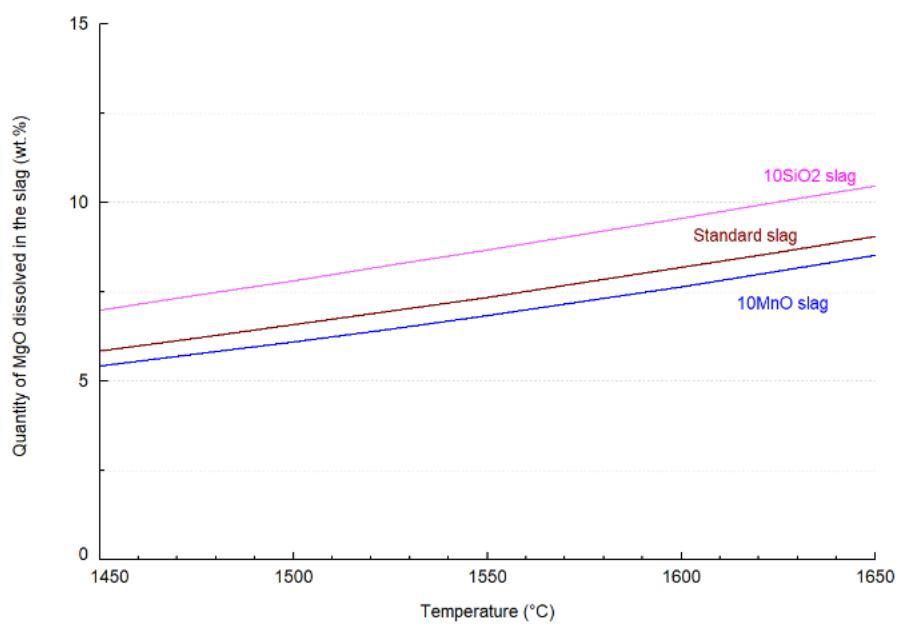
On the other hand, the sample from the dipping test corroded using the SiO₂ slag had a higher dissolution compared to the other sample. This can be explained by the C_{sat} of MgO in the different slags. C_{sat} of the three slag was thus compared by performing calculations with the Equilib module of Factsage. The results were obtained by inputting 100 g of MgO with 100 g of slag (composition given in Table 1). The obtained results are presented in Figure 15. The graph indicated that the C_{sat} of the 10SiO₂ slag is the highest and the C_{sat} of the 10MnO slag is the lowest which is in accordance with the literature [21].

According to the Noyes-Nernst's equation Equ. 6 and Equ. 7, the corrosion of MgO will increase with a higher C_{sat} . The C_{sat} of the 10SiO₂ is the highest according to Figure 15. This explained why the samples corroded using the 10SiO₂ exhibits the highest corrosion. Moreover, according to literature, increasing SiO₂ content in the slag (i.e decreasing the basicity of the slag) increases the dissolution of MgO and consequently the corrosion of the MgO bricks [19-22].

The graph also indicates that the C_{sat} of the 10MnO slag is the lowest. In addition to the higher formation and reoxidation of MgO gas, this can explain the presence of the MgO layer in the sample corroded by the 10MnO slag and its absence in the samples corroded using the standard slag or the 10SiO₂ slag. Moreover, the viscosity of the slag can also affect the dissolution of MgO according to Equ. 6 and Equ. 7. The calculation of the viscosity was performed using the viscosity module of Factsage. The results are presented in Figure 16.

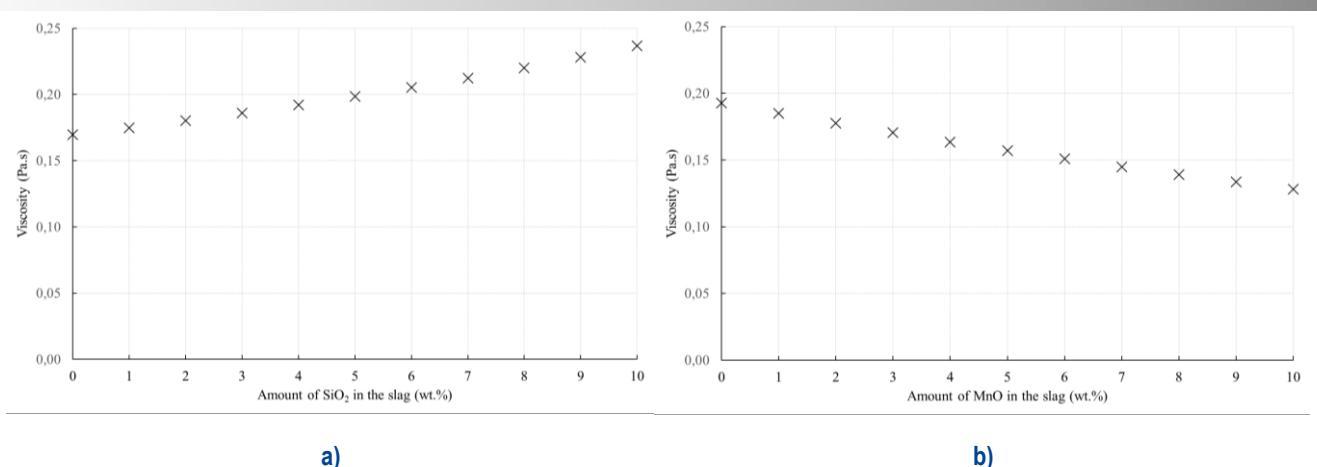
Figure 16: Calculation of the viscosity of calcium-aluminate slag with increasing content of a) SiO₂ and b) MnO using Factsage at 1550 °C.

This indicates that adding SiO₂ to the slag will increase the viscosity of the slag; it should lead to a decrease of the dissolution of MgO. However, the results of the dipping test suggest that the corrosion of the samples using the $10SiO_2$ slag was the highest as the highest width loss was observed for the sample corroded by the $10SiO_2$ slag at 1600 °C in Figure 12. On the other hand, adding MnO to the slag will decrease the viscosity of the slag and thus should increase the corrosion of MgO. However, the sample corroded using this slag exhibits the same corrosion as the sample corroded using the standard slag. This indicates that the MgO layer protects, in part, the sample from corrosion and/or that C_{sat} has a higher impact on the corrosion than the viscosity η .
